Developing risk management practices in a hospital environment

**A comprehensive assessment of the usability of the facilities
at a one Central Hospitals in Finland**

Veli-Matti Pietarinen

21.2.2012

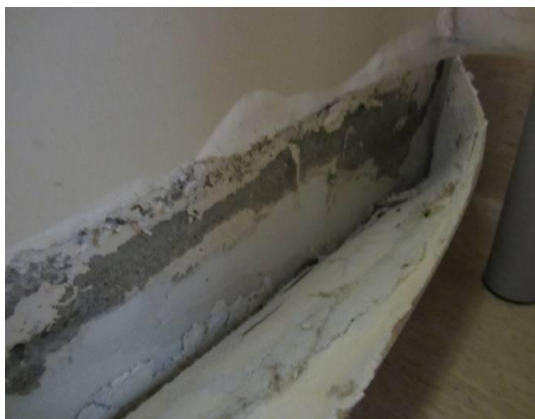
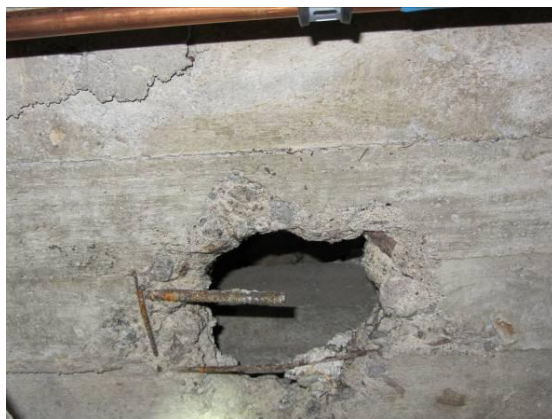
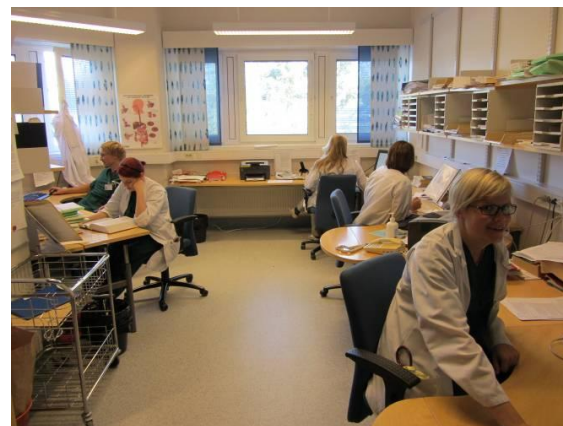
- **Properties built in the 1950s**

- cellar wall and floor structures » effect of soil humidity
 - water vapour resistant floor surfaces damaged by soil moisture » (VOC)
 - supporting structure's wall elements touching the ground, which were heat insulated on the inside
- The double slab beams in the intermediate floor structure » organic insulations, boardings
 - non-insulated inlets between work and technical spaces
 - impurities in floor specific structures and moisture prone structures travel between different spaces and floors
- The air quantity in the departments work places (offices, reception points, care facilities) is not sufficient with regard to the number of people that use the facility

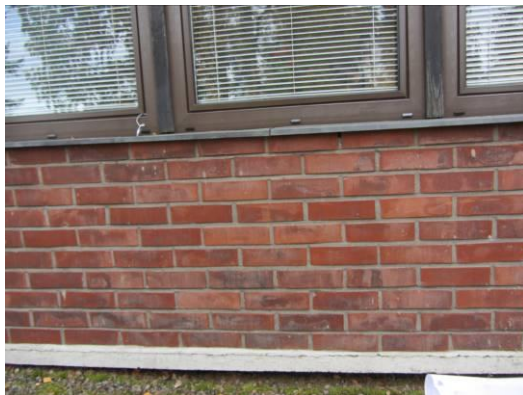
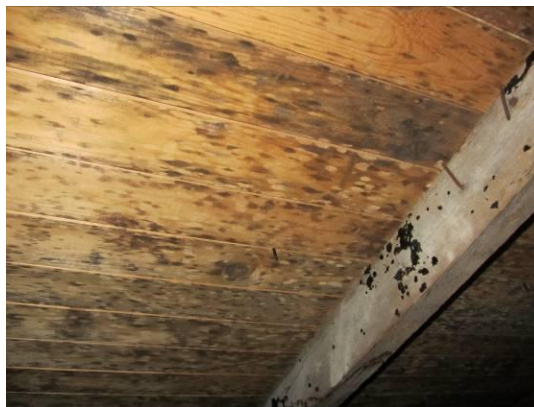
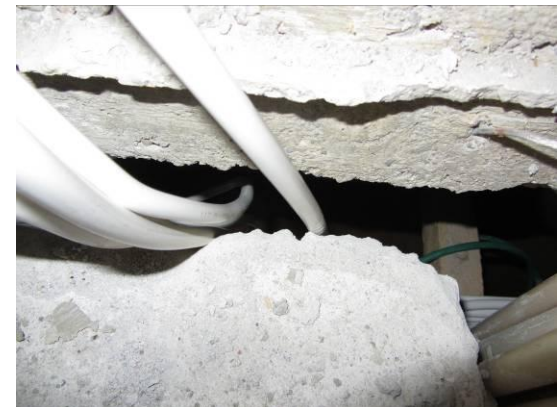
- **Properties built in the 1960s**
 - non-ventilated and ledger structured brick/wool/brick exterior wall construction
 - supporting structure's wall elements touching the ground, which were heat insulated on the inside
 - double slab roof structures, clear signs of microbe damage in the roof boarding
 - roof structures showed visible non-insulated inlets to workspaces

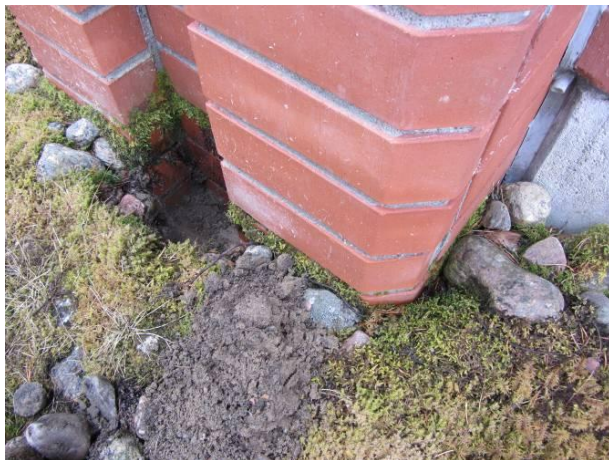
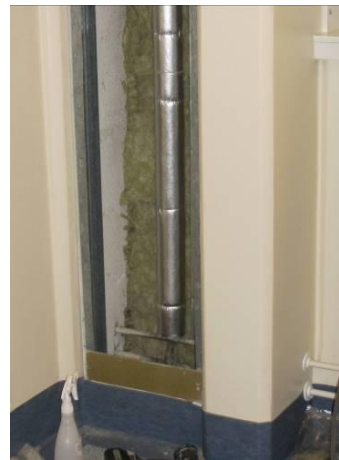
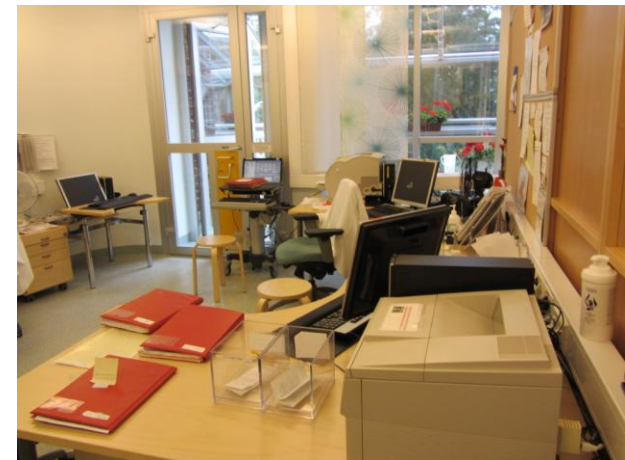
- **Properties built in the 1980s**

- mineral wool insulation in the double beam structure for socle split » moisture and mould damages
 - no firestops between floors in the double beam structure of the exterior wall construction
 - mould damage to the socle split was connected through airways to upper floors
- water vapour resistant floor surfaces damaged by soil and structure moisture » (VOC)
- The air quantity in the departments work places (offices, reception points, care facilities) is not sufficient with regard to the number of people that use the facility

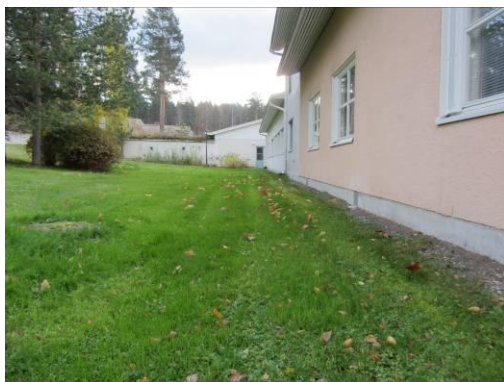
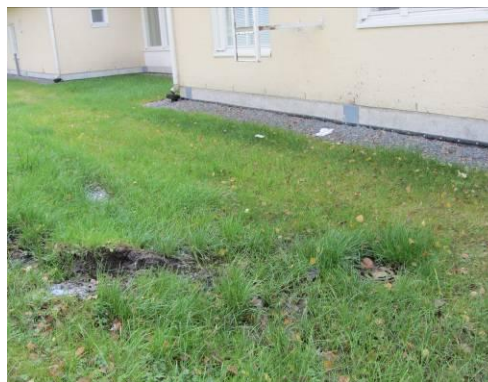
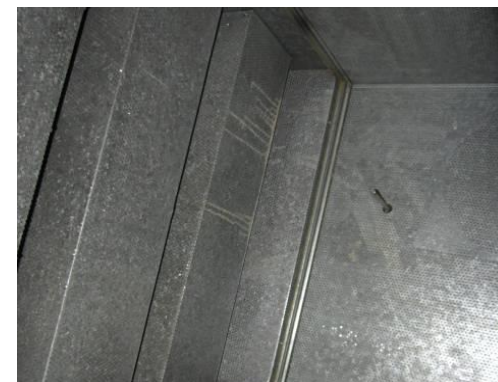
- **Properties built in the 1990s**
 - The ventilation of brick-wool-brick construction of the exterior walls was lacking
 - functionality of moisture technology of the structure required further examination
 - The ground surfaces in the area surrounding the building inclined in the direction of the building
 - visible signs of excessive moisture load
 - Sources of mineral wool fibre were found in silencers for supply air devices, silencers for main air ducts as well as in some supply air terminal devices

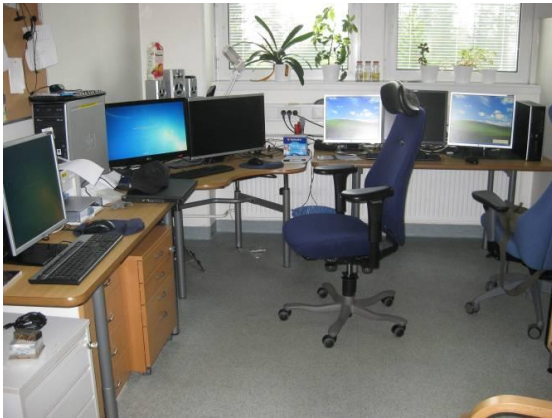
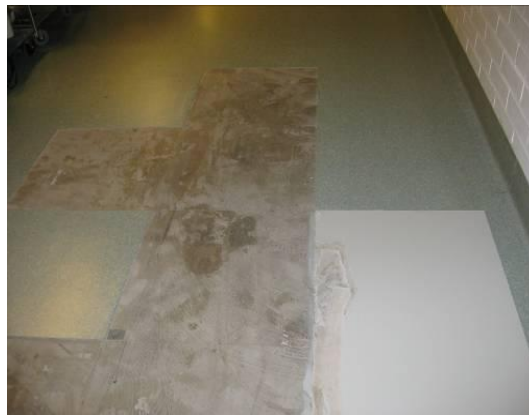
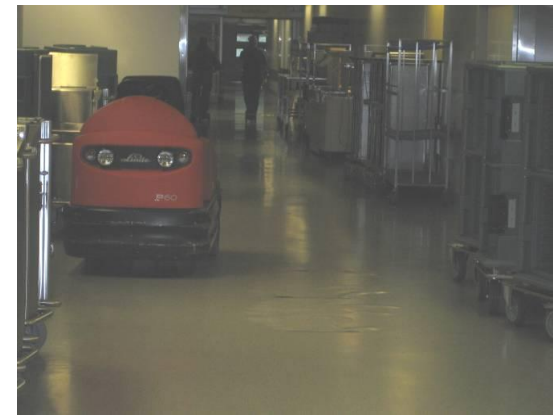
- **Properties built in the 2000s**
 - The air quantity in the departments work places (offices, reception points, care facilities) is not sufficient with regard to the number of people that use the facility
 - water vapour resistant floor surfaces damaged by soil and structure moisture » (VOC)
