Fremtidens sykehus – teknikk og areal og kirurgi på bygg (..... og kirurgi og bygg)

Egil Lingaas

Avd. for smittevern

Oslo universitetssykehus

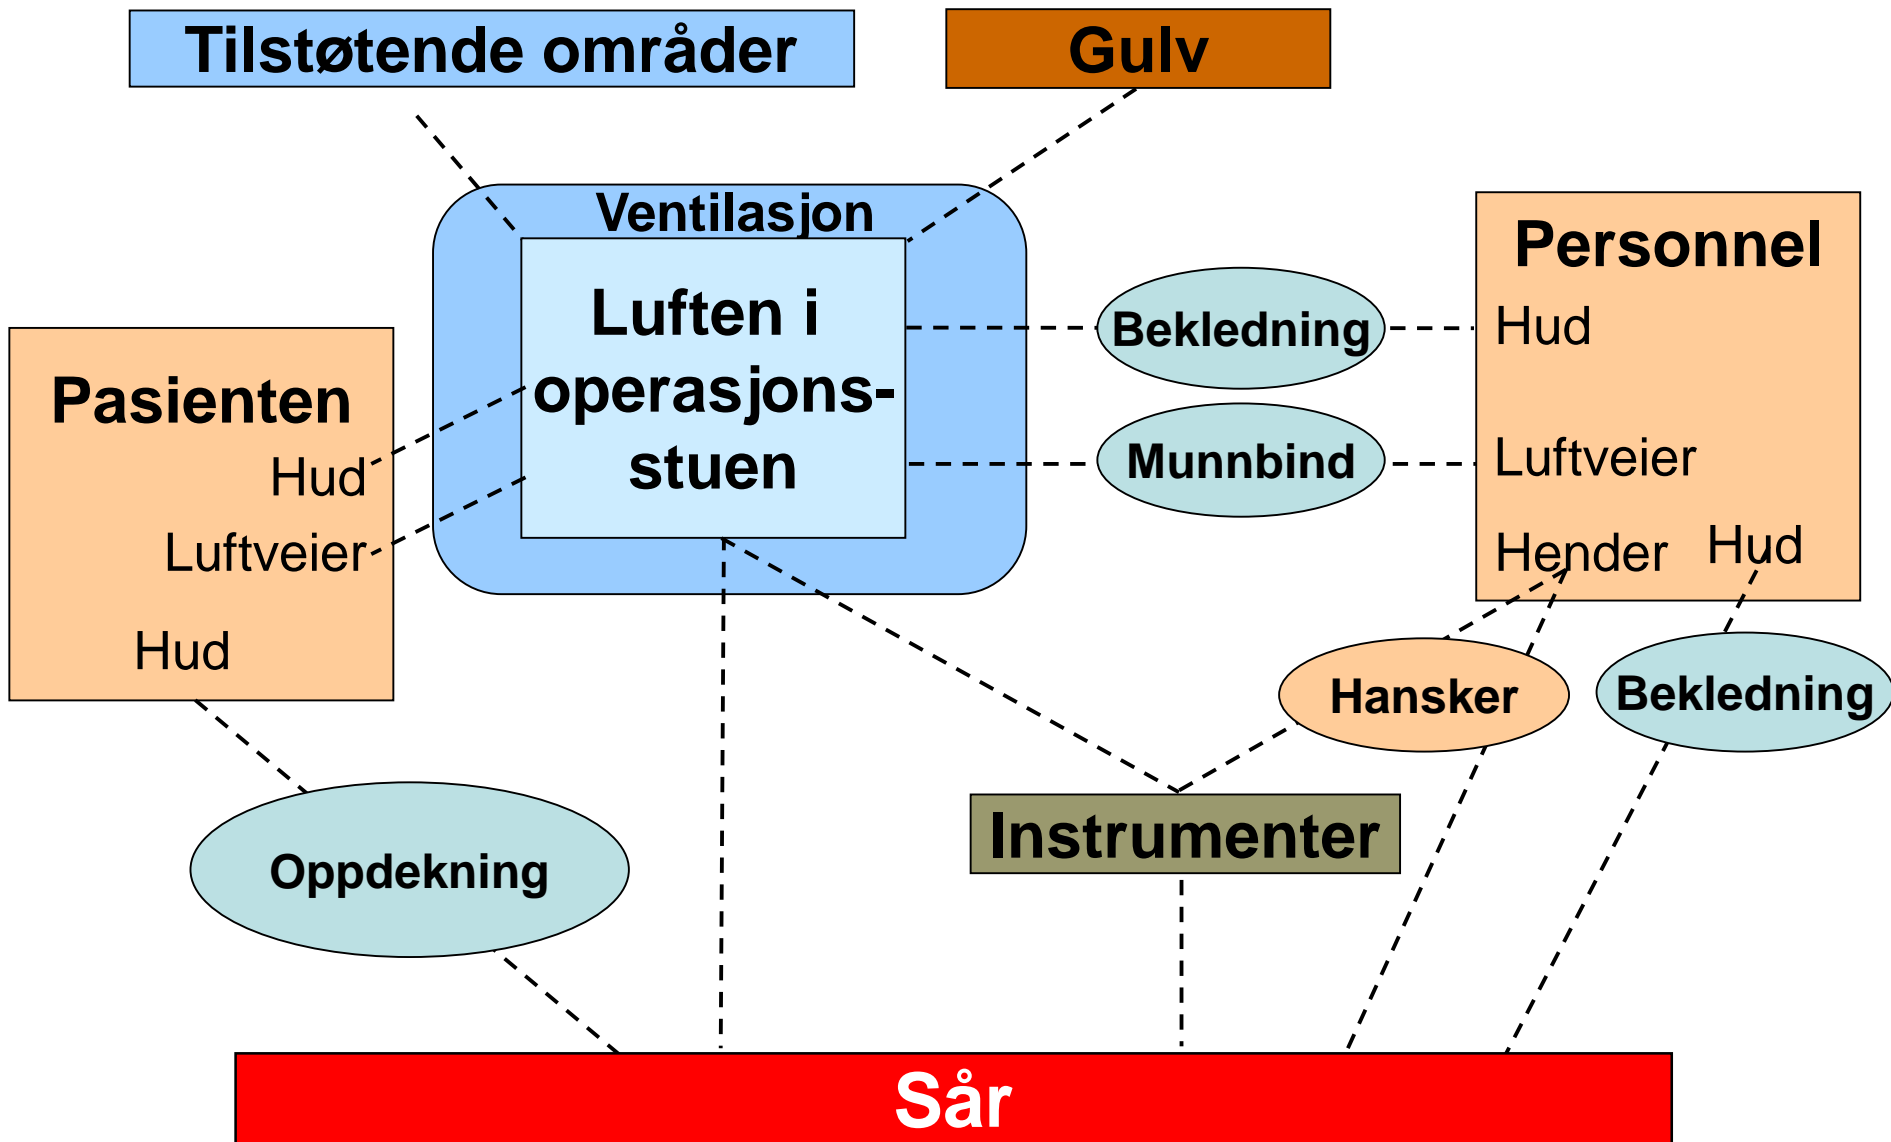
Opprinnelsen til kontaminasjon av operasjonssår

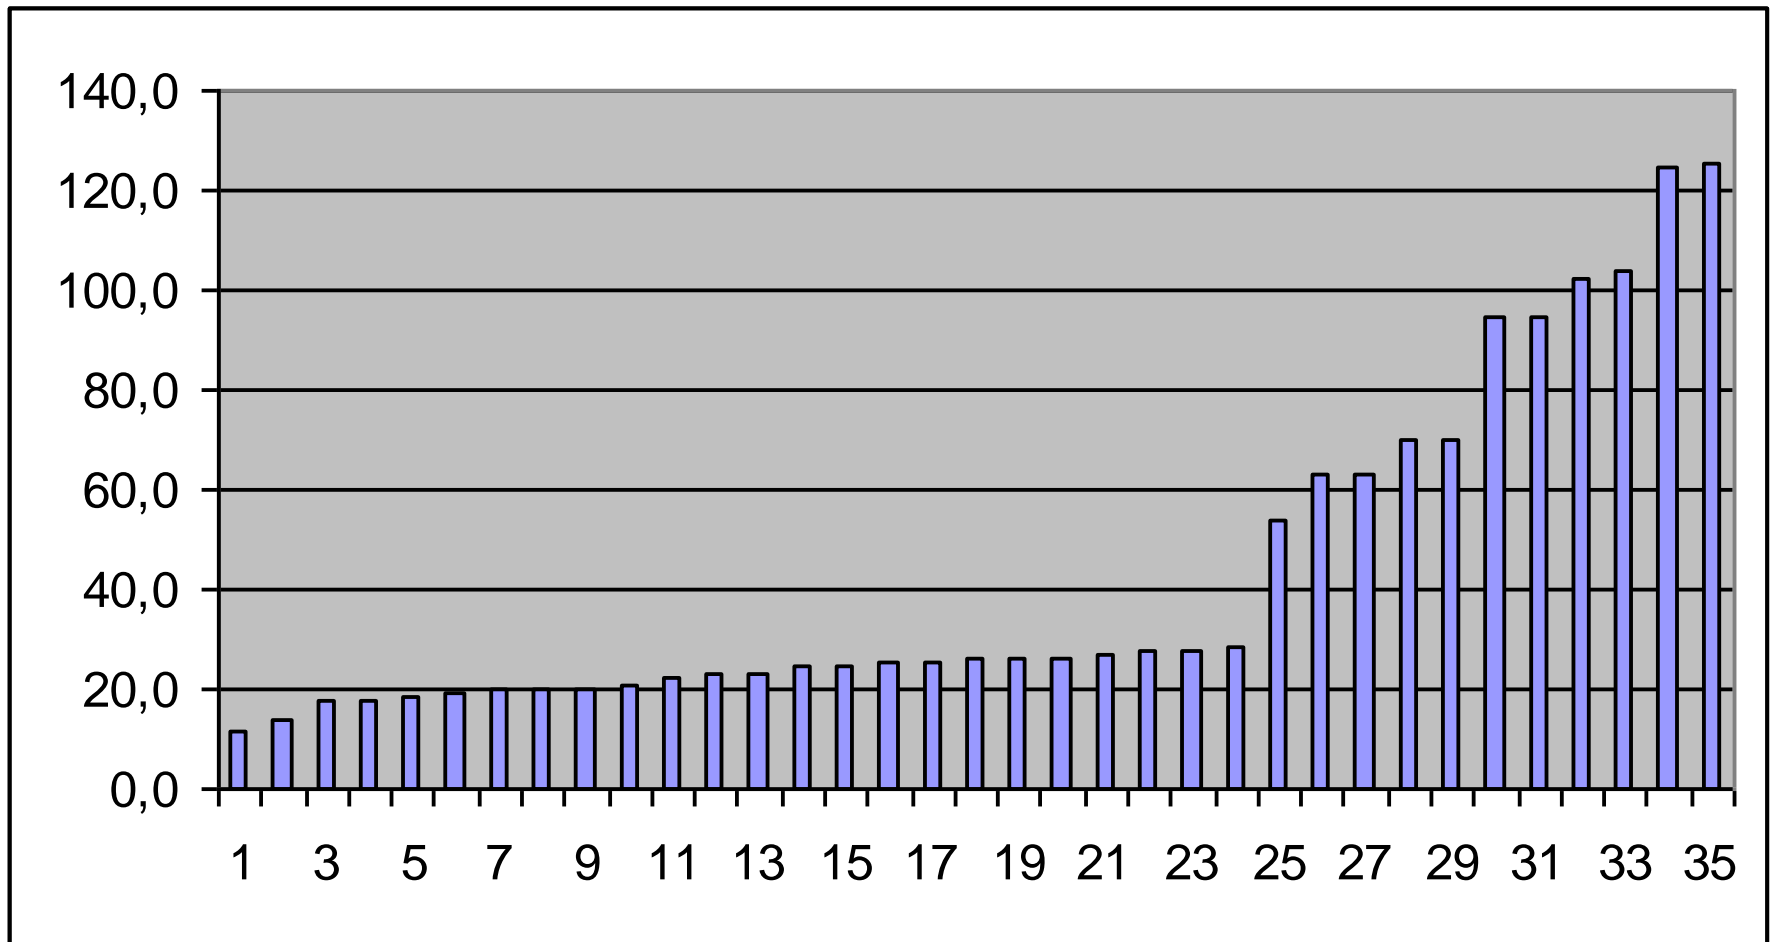
Ventilasjon i ortopediske operasjonsstuer i Helse Sør-Øst 2008

Antall luftskiftinger per time

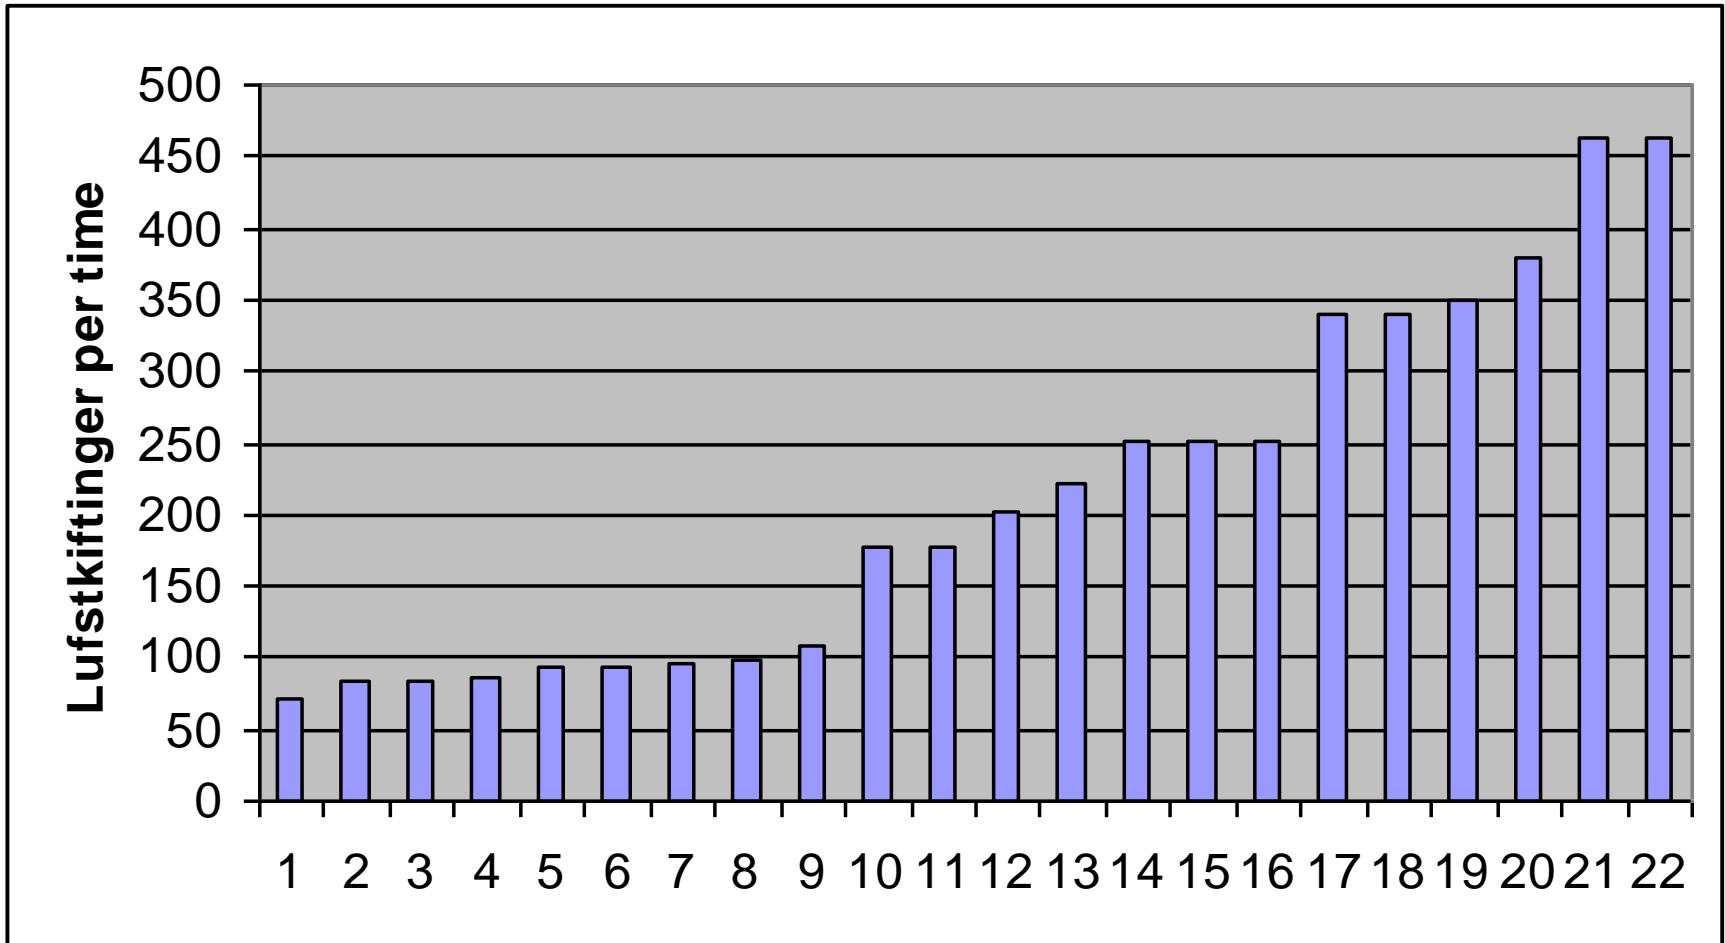
Antall luftskiftinger per time under taket

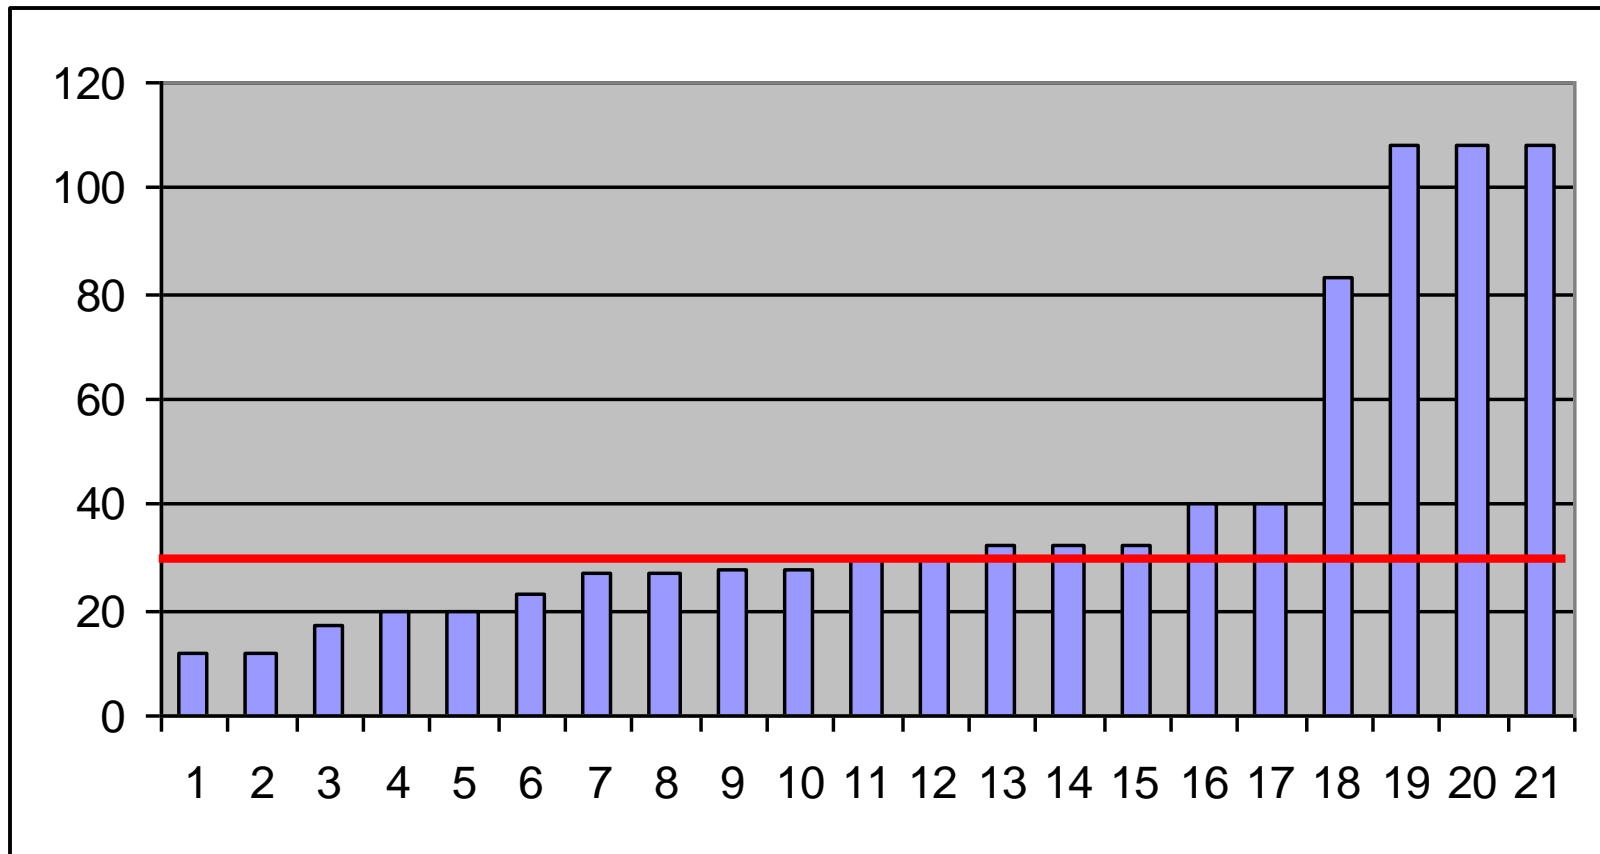
Oppgitt lufthastighet ut gjennom taket

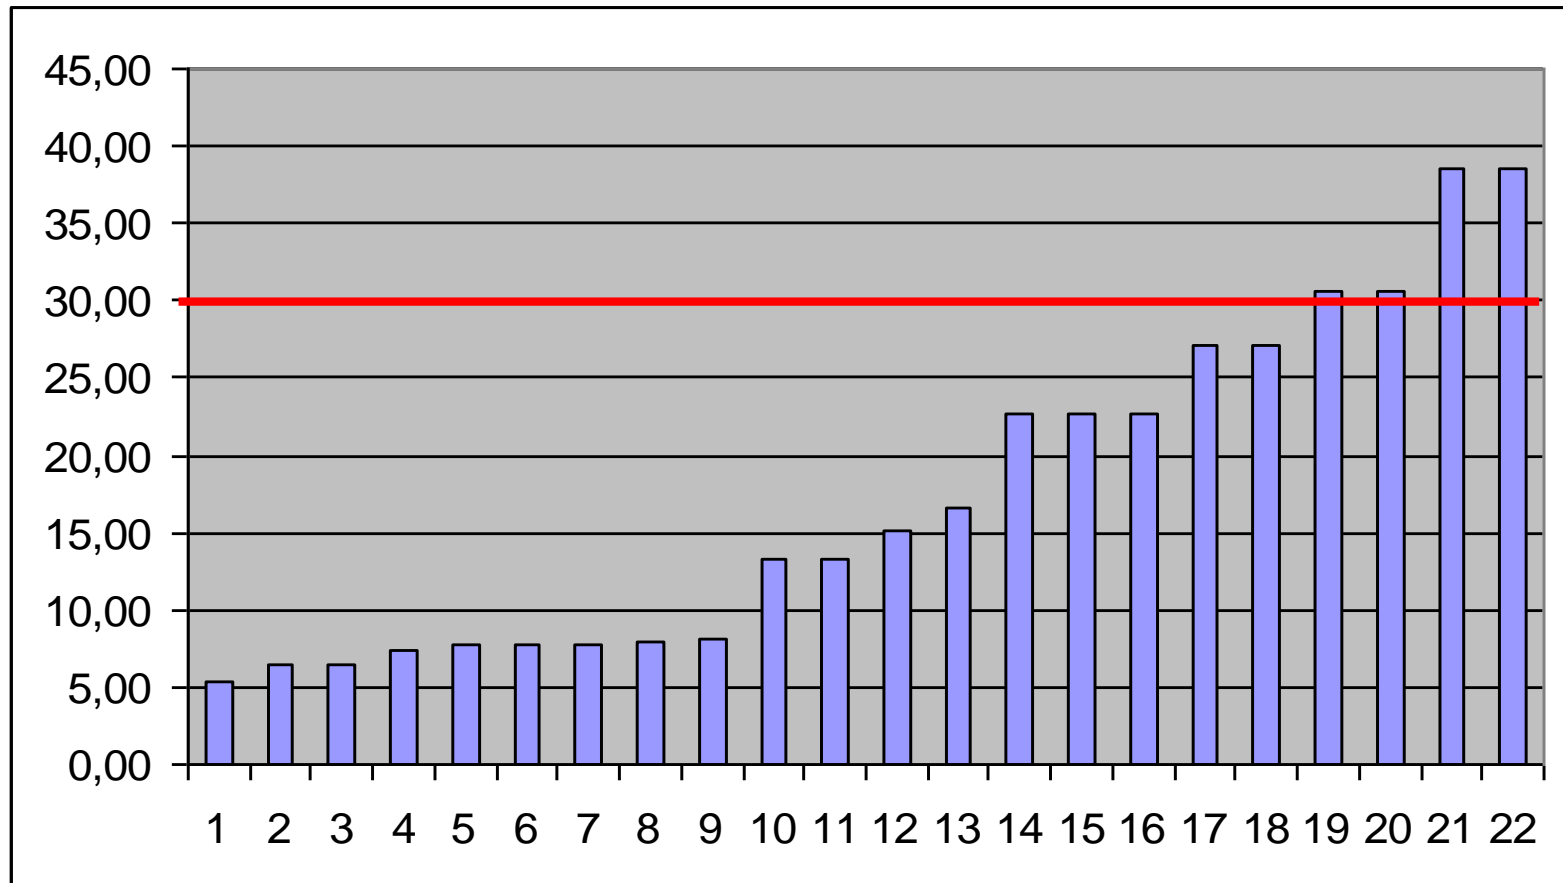
Beregnet lufthastighet ut gjennom taket

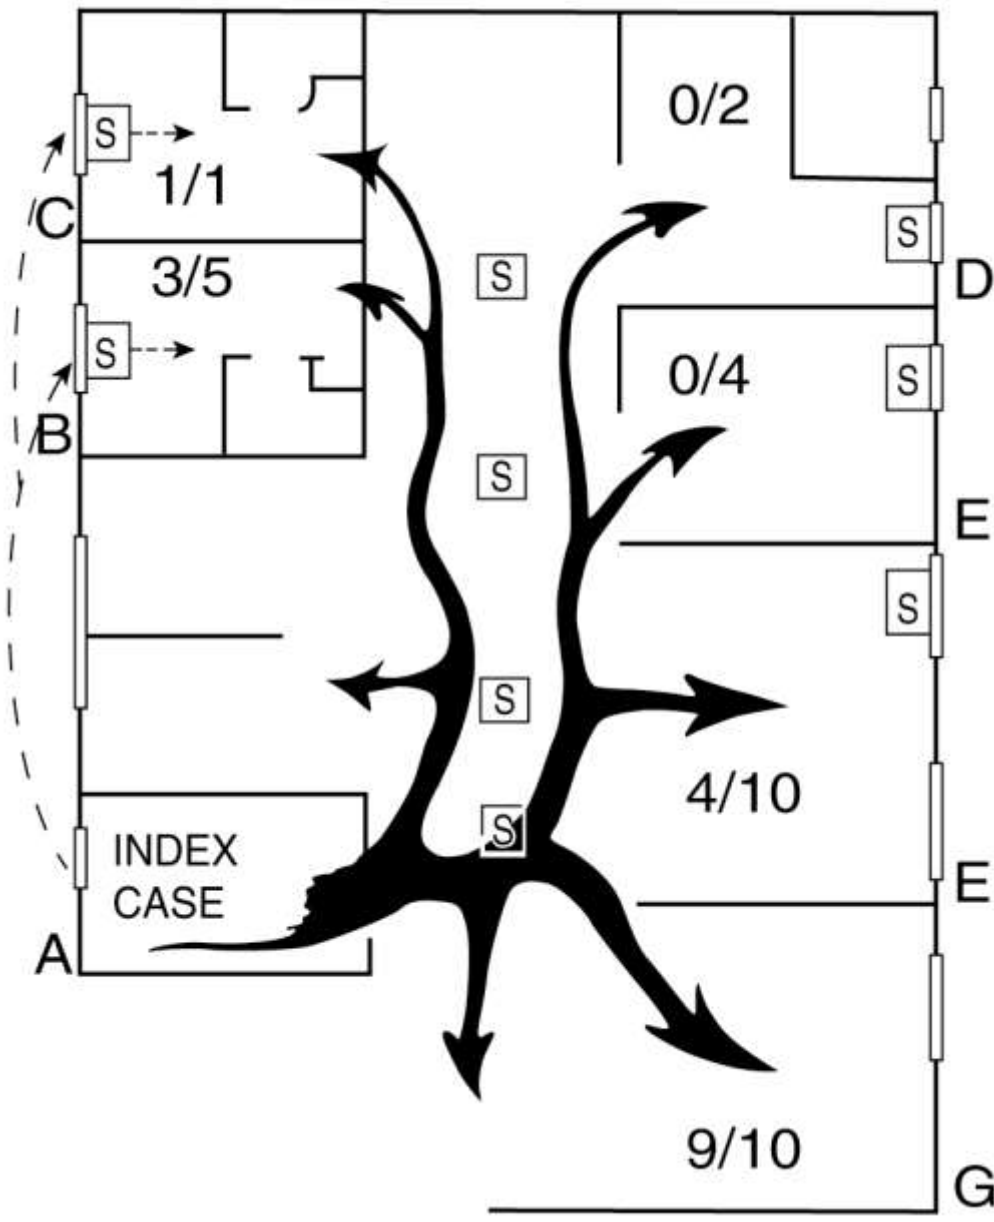
Spatial distribution of cases of chickenpox and airflow patterns on ward

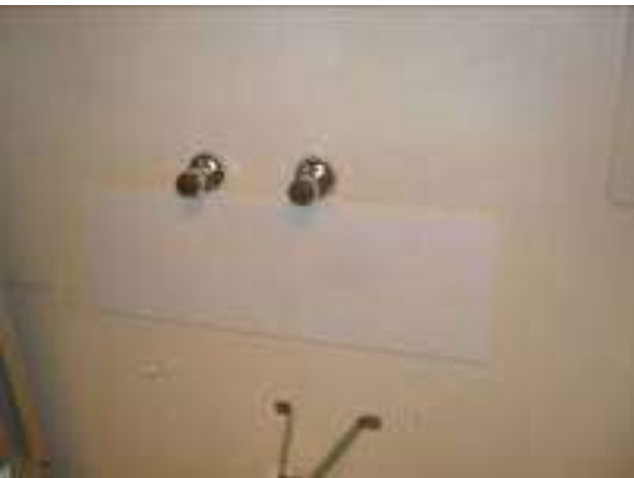
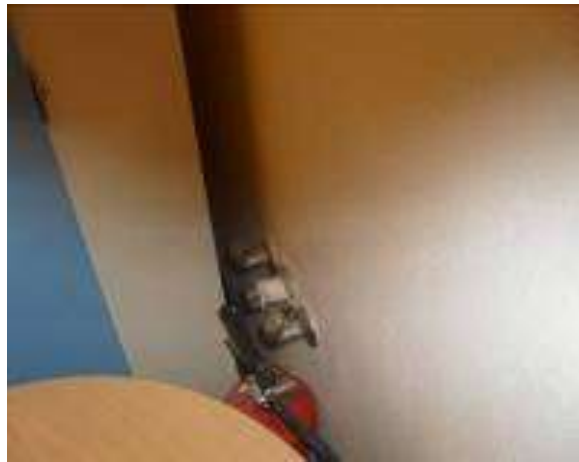
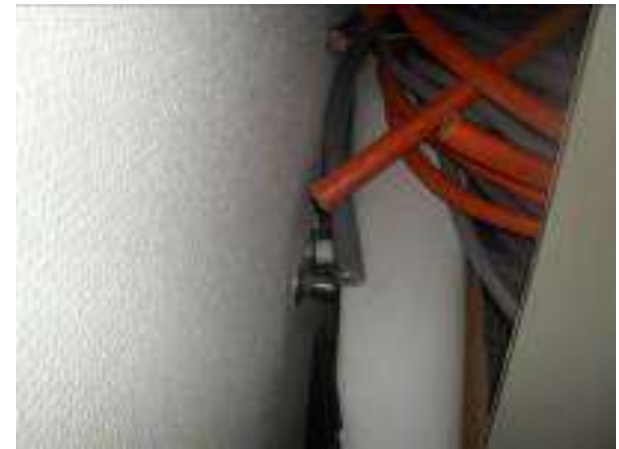
Amputerte rør etter fjerning av vask/servant

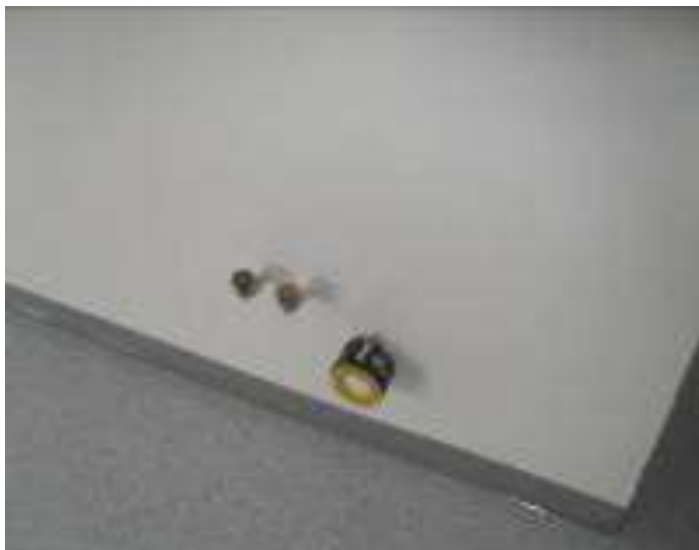
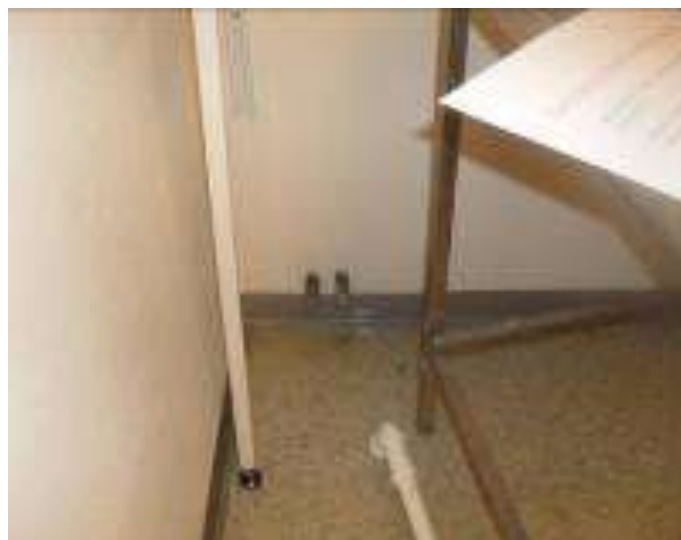
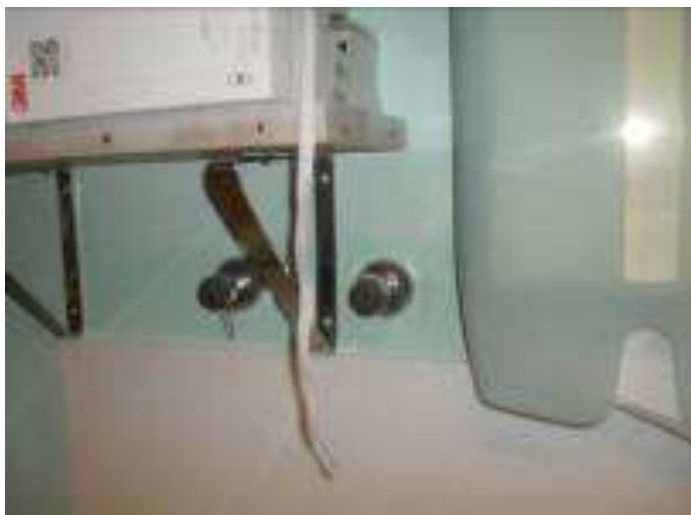
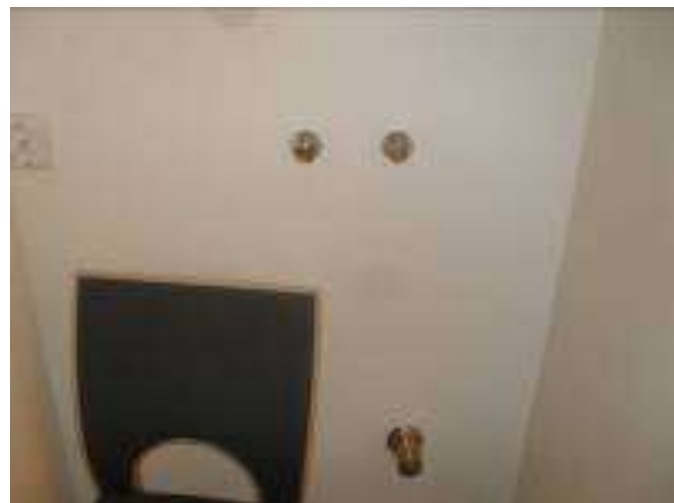
Amputerte rør etter fjerning av vask/servant

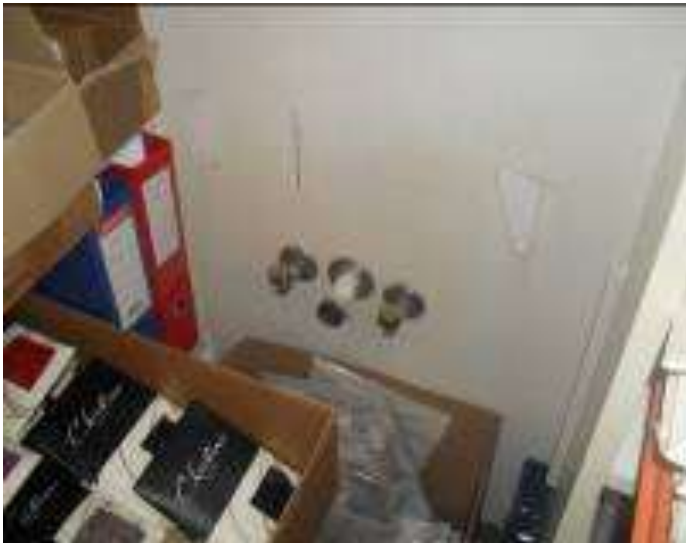
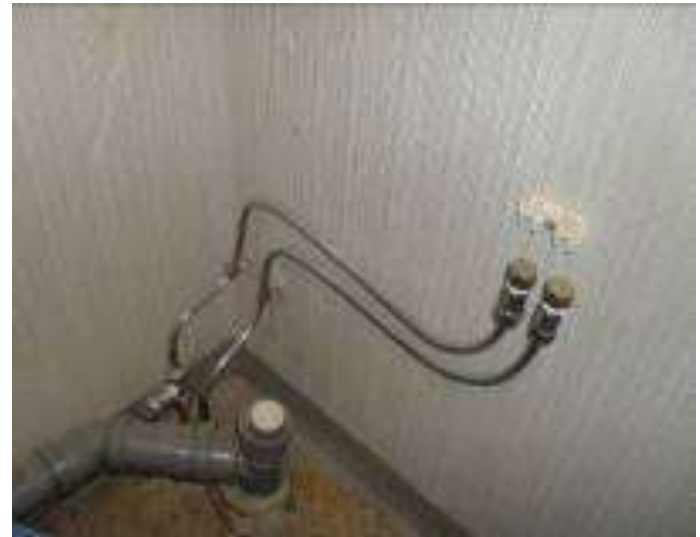
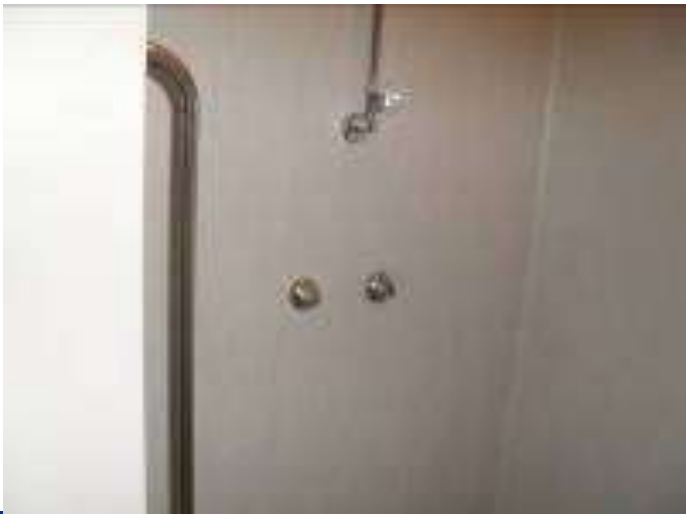
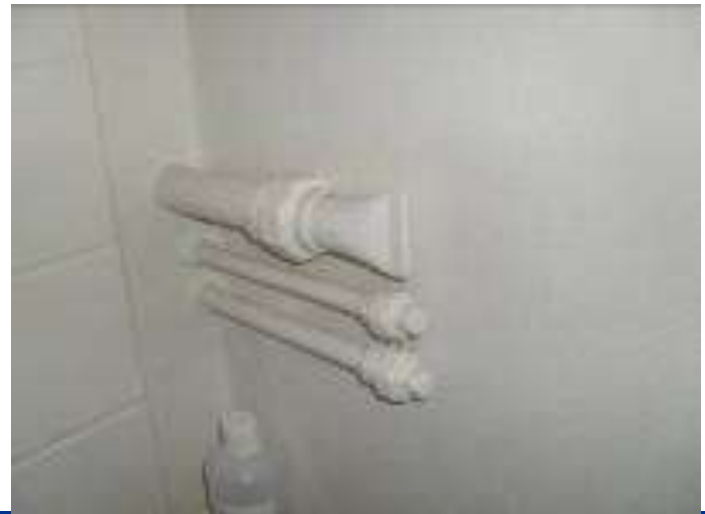
Amputerte rør etter fjerning av vask/servant

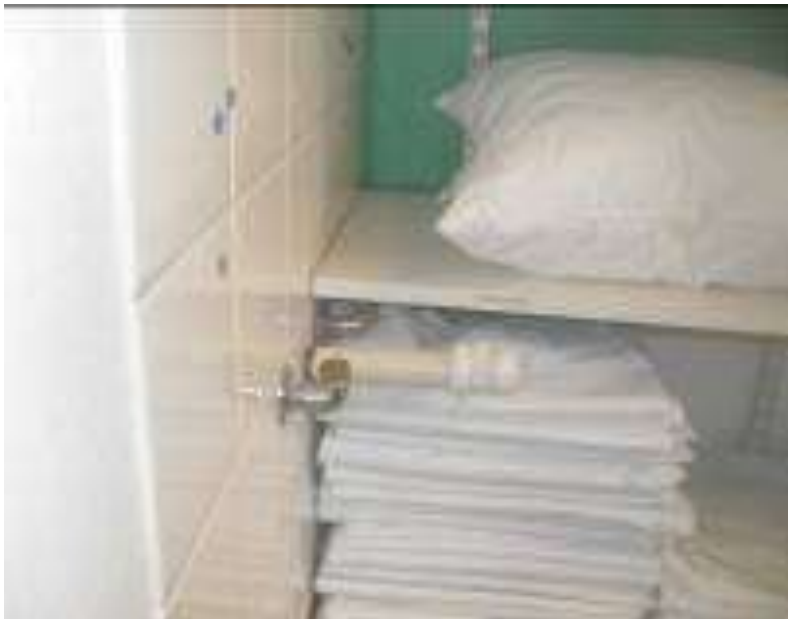
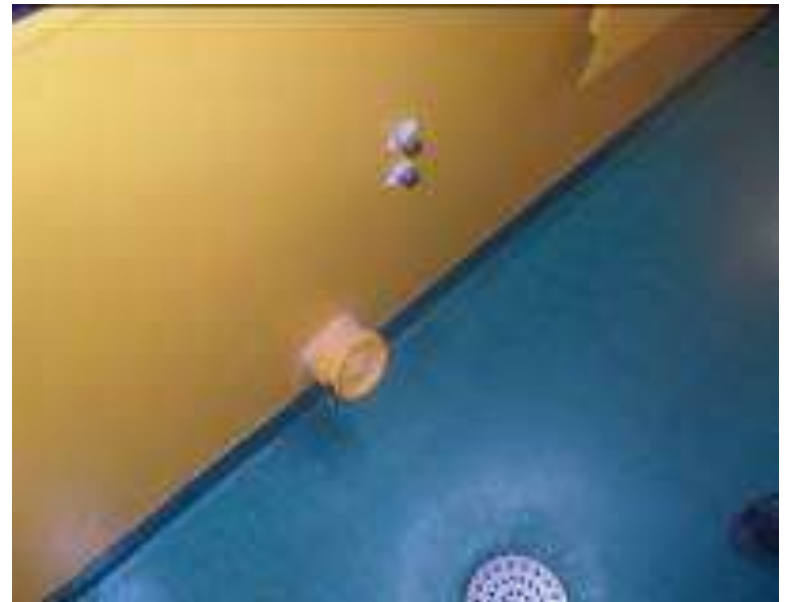
Amputerte rør etter fjerning av vask/servant

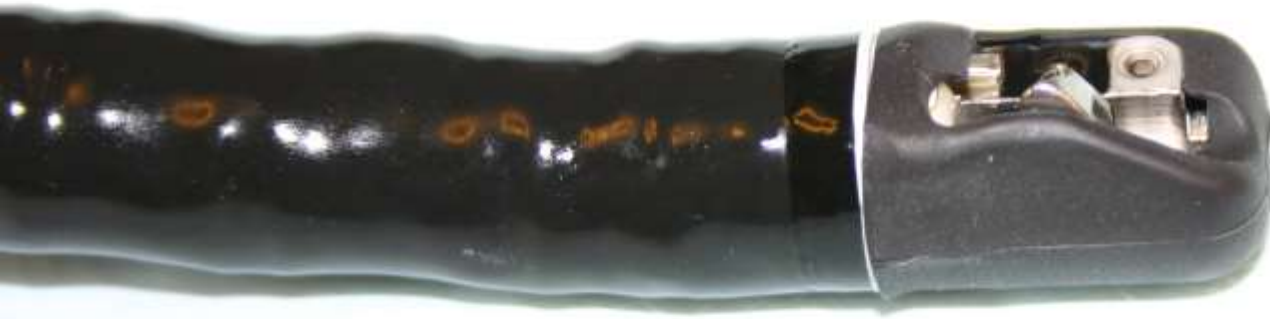
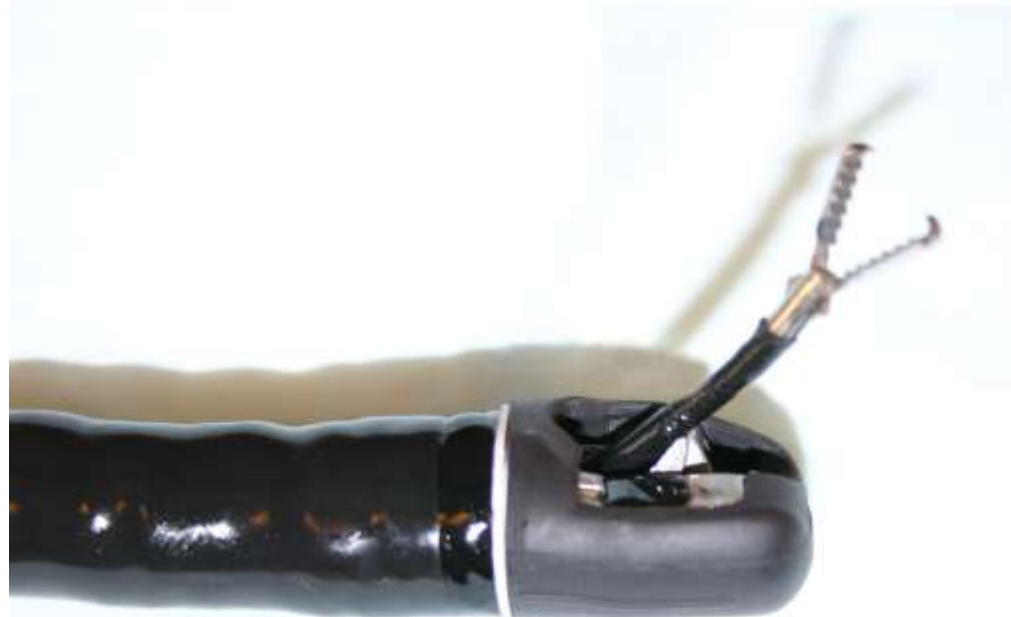
Duodenoskop (ERCP)

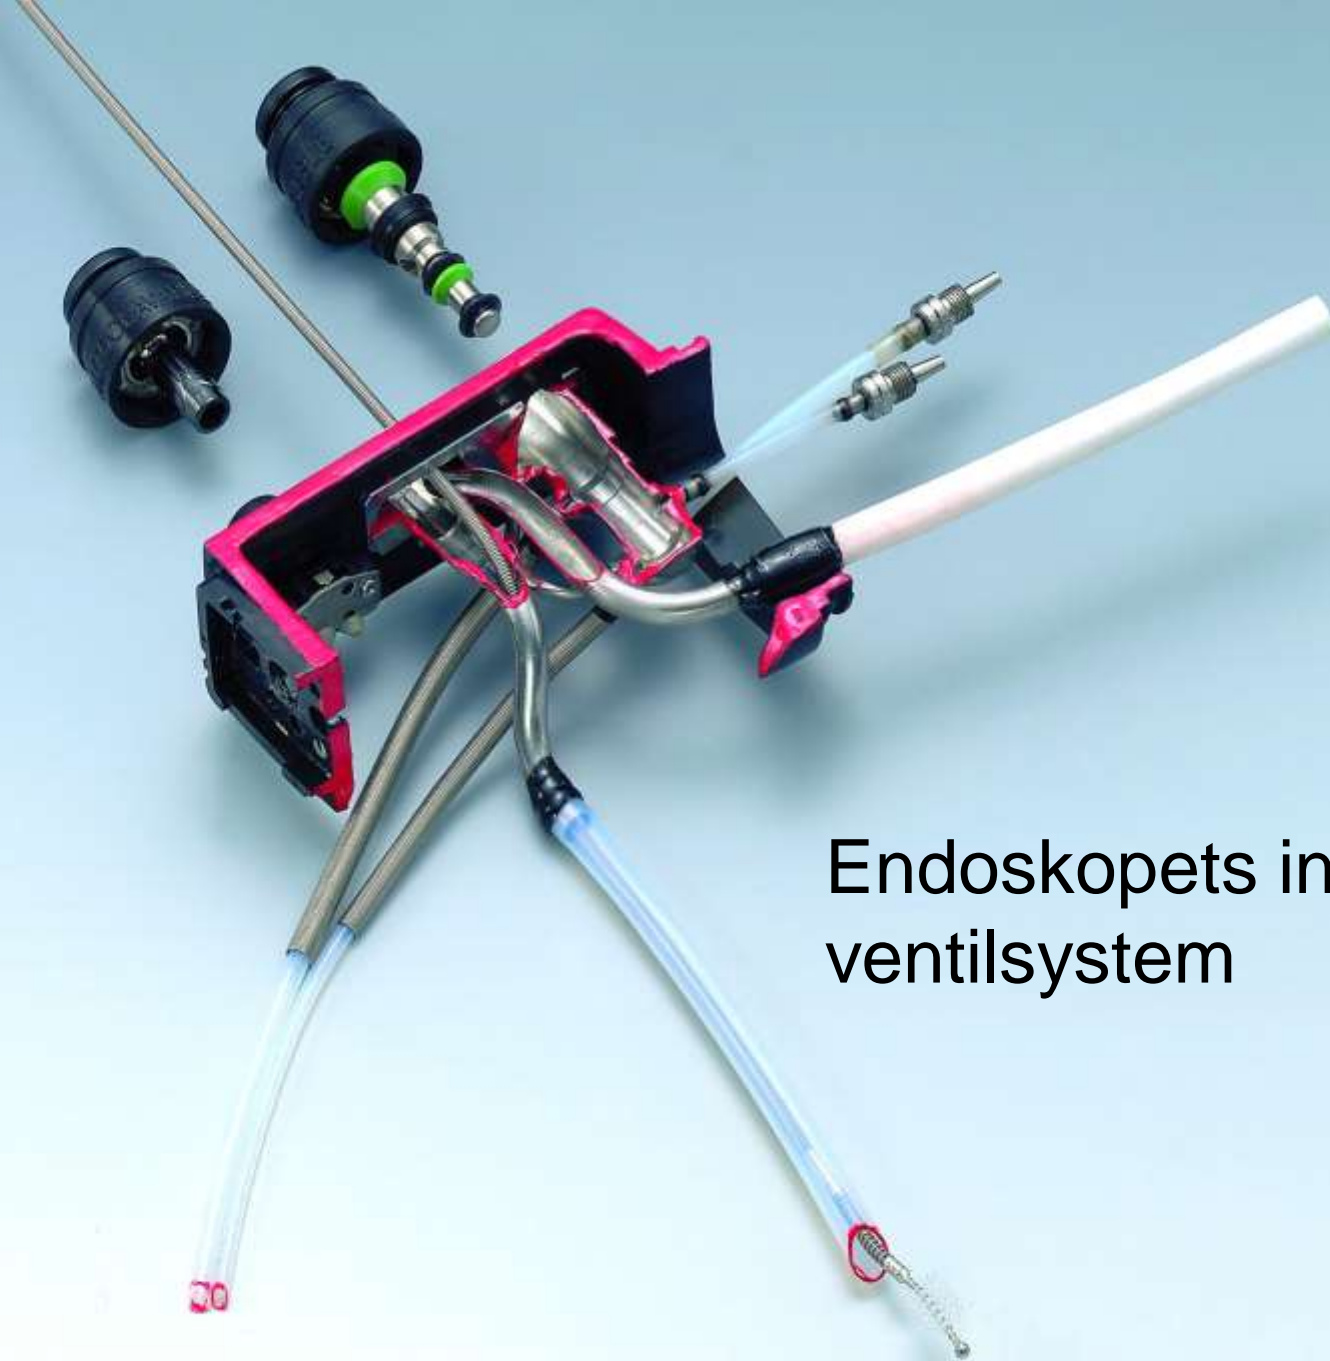
Endoskopets indre
ventilsystem

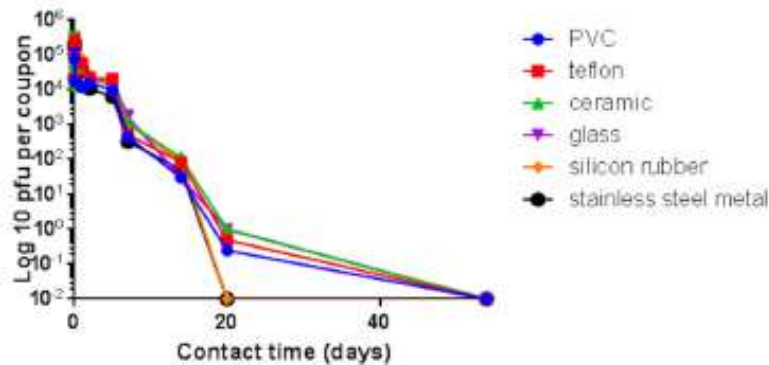
Survival of MNV infectivity on common surface materials

FIG 1 Persistence of infectious murine norovirus on common surface materials. Approximately 5×10^5 PFU of infectious virus was applied to 1-cm² samples of test surfaces and incubated at room temperature. At various time points, virus was removed from the surfaces and assessed for infectious virus by plaque assay as described in the text. No significant reduction in infectivity of norovirus occurs on any surface over 2 h at room temperature. This was followed by a steady decline in the infectivity of norovirus. Infectious virus was present on all surfaces except stainless steel and silicon rubber at 20 days. However, because the infectious dose was very low (only 10 virus particles), this represents a considerable risk of infection spread. Slightly higher levels of infectious virus were recovered from ceramic surfaces commonly used in bathroom and kitchen tiles. Error bars represent \pm standard deviations, and data are from multiple experiments.

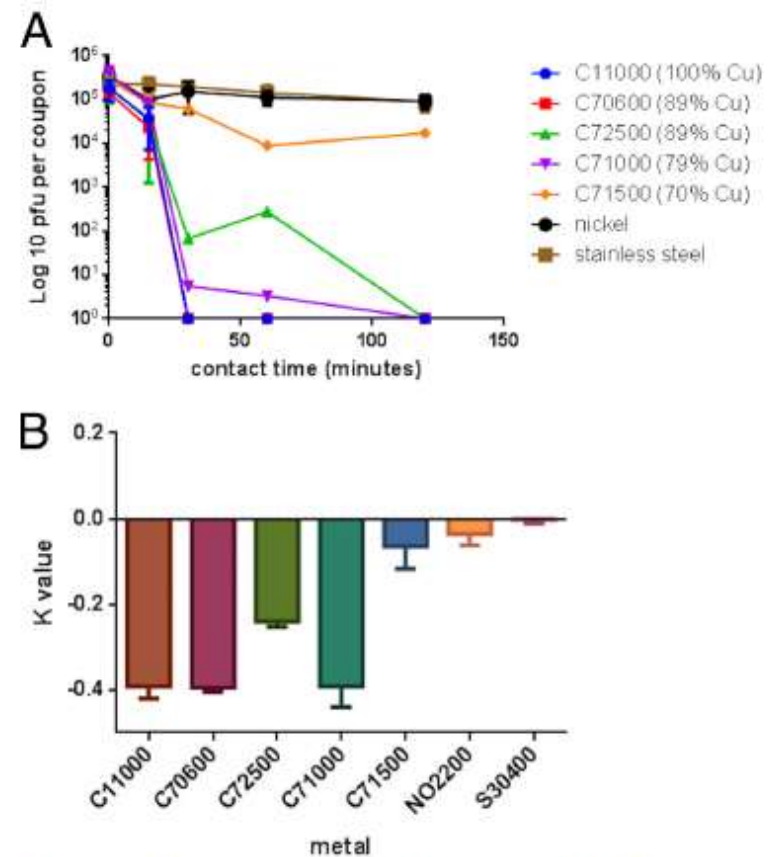
FIG 2 Inactivation of MNV on copper nickels. (A) Survival of MNV infectivity on copper nickels. Approximately 5×10^5 PFU of infectious virus was applied to 1-cm² samples of test surfaces and incubated at room temperature. At various time points, virus was removed from the surfaces and assessed for infectious virus by plaque assay as described in the text. MNV was rapidly inactivated on copper and C70600. The extent of inactivation on copper alloys was proportional to the percentage of copper, except with alloy C72500, which is not as effective as alloys with lower percentages of copper. Stainless steel and nickel do not have any antiviral activity. (B) Rate of MNV inactivation on copper nickels over the first 30 min of contact at room temperature. The inactivation rate, K , was calculated as described previously (20). C11000 (100% copper), C70600 (89% copper), and C71000 (79% copper) all displayed similar, fast inactivations of MNV for the first 30 min of contact. Inactivation on C72500 was slower, even though its copper content is high (89%).

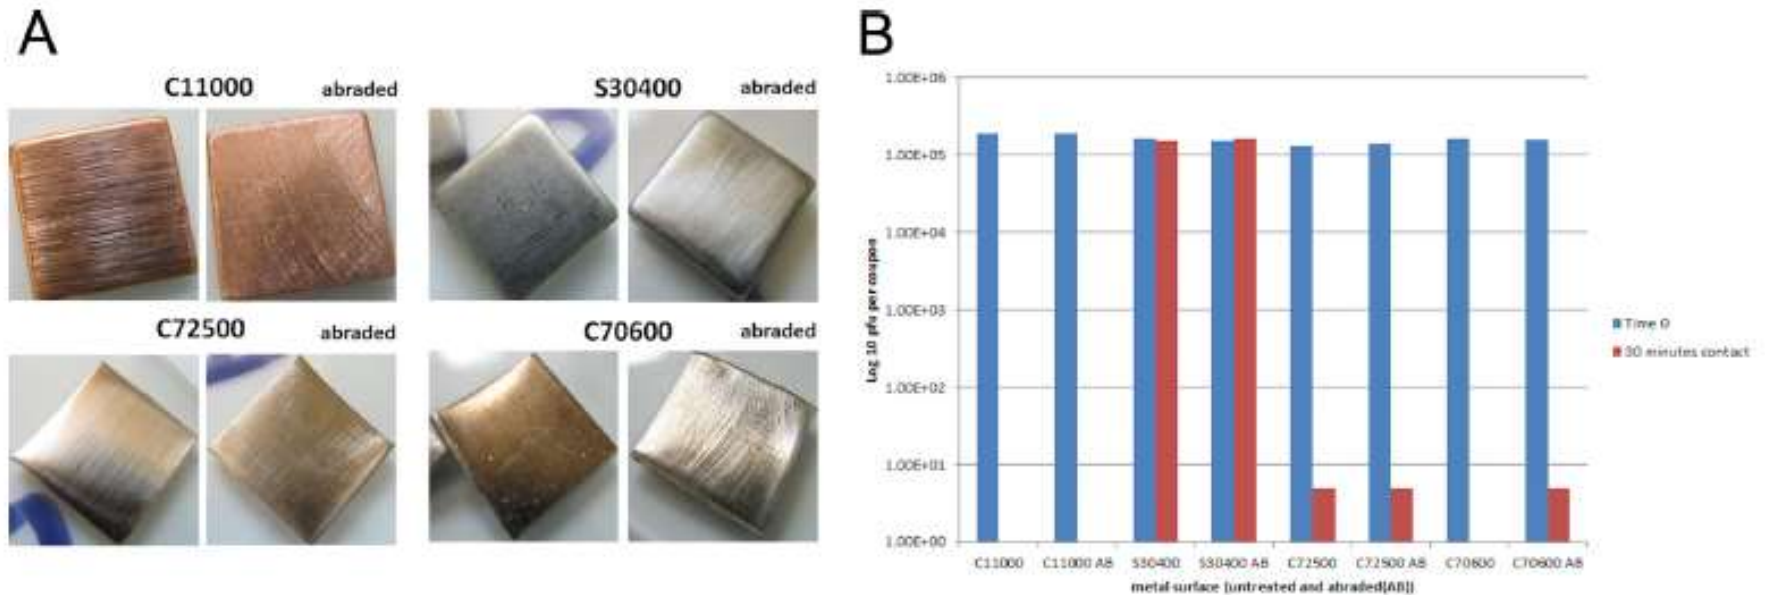
FIG 3 Comparison between two copper nickels, C72500 and C70600) containing 89% copper. (A) Appearance of copper alloys, i.e., abraded and unabraded (copper and stainless steel controls). (B) Abrasion of the oxide layer on C70600 slightly reduces antiviral efficacy. Approximately 5×10^5 PFU of infectious virus was applied to 1-cm² samples of abraded and unabraded metal coupons and incubated at room temperature. At various time points, virus was removed from the surfaces and assessed for infectious virus particles by plaque assay as described in the text. Abrading the surface of alloy C72500 did not make any difference in its efficacy in inactivating MNV. It is unclear whether the tin content of this alloy affects efficacy. Abrading the surface of alloy C70600 reduces antiviral efficacy; i.e., the alloy surface has an effect on MNV.
